Manhole Inspection Summary

Manhole # S67O__015MH

Location Address: **6300 Boston St.** Cross Street: **CAve.ndish Way**

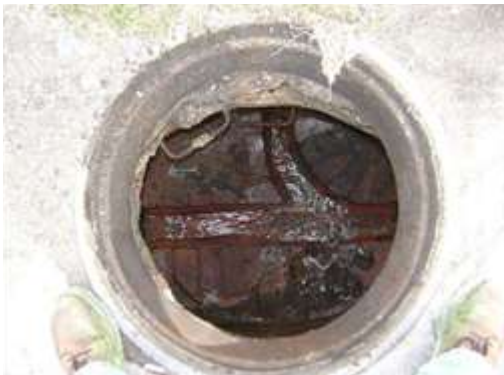
Defect 1

Frame Offset: **1** (in.) Condition: ☒ Sound ☐ Cracked ☐ Leaks

1 in. frame offset

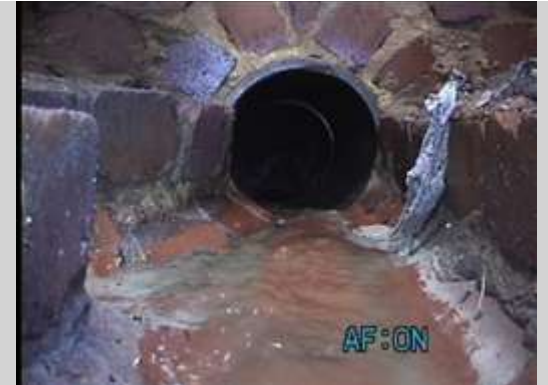
12 O'Clock Outflow

8 in. Circular Gravity Sewer
Pipe Out @ 12 O'Clock

Pipe Height: **8.4** (in.) Rod and Bar (Angled)
Pipe Material: **Clay** ☐ Pipe Lined
Invert Depth: **5.67** (ft.) Flow Characteristics: **Fast**
Deposits: ☒ None ☐ **Mud** ☐ Sludge ☐ Debris ☐ Grease
Silt Depth: (in.) Deposits Extent:
Infiltration: **None** Pipe Seal Cond: **Sound**

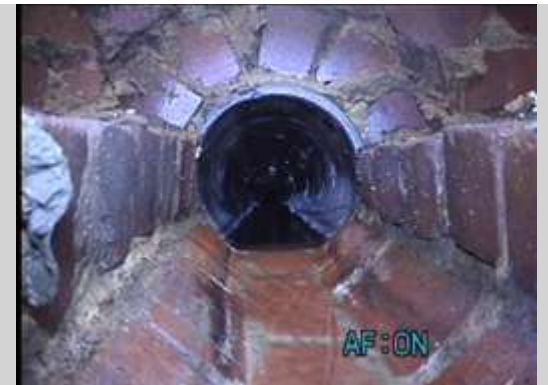
6 O'Clock Inflow

8 in. Circular Gravity Sewer
Pipe In @ 6 O'Clock

Pipe Height: **8.4** (in.) Rod and Bar (Angled)
Pipe Material: **Clay** ☐ Pipe Lined
Invert Depth: **5.58** (ft.) Flow Characteristics: **Fast**
Deposits: ☒ None ☐ **Mud** ☐ Sludge ☐ Debris ☐ Grease
Silt Depth: (in.) Deposits Extent:
Infiltration: **None** Pipe Seal Cond: **Sound**

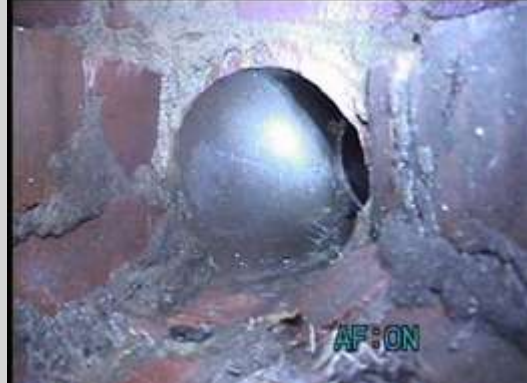
9 O'Clock Inflow

6 in. Circular Gravity Sewer

Pipe In @ 9 O'Clock

Deposits: ☐ None ☒ **Mud** ☐ Sludge ☐ Debris ☐ Grease

Silt Depth: **0.25** (in.) Deposits Extent: **Light**
